Staffhouse #14

## State Historic Sites Inventory Form

historic Staffhouse #14

### 2. Location Springfield Hospital Center

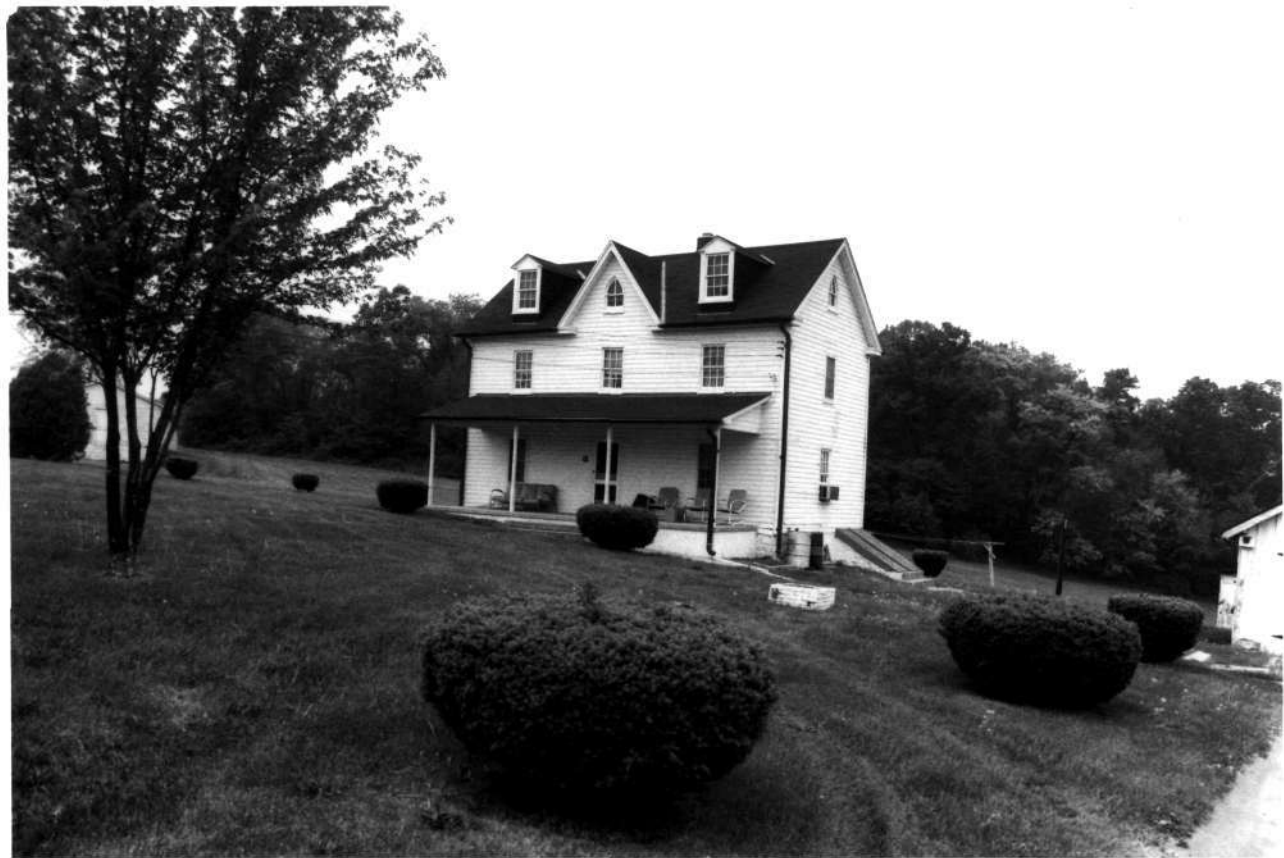
West

The windows, as seen on the west facade and throughout the building, are 6/6 double-hung sashes with wooden sills and surrounds. Two windows flank a central doorway. The entrance shows a screen door plus a single wooden door with a glass transom. A lean-to porch shadows the entire first floor. Thin wooden posts with minor detail support the porch. The posts connect to a cement deck.

The west facade displays a central cross gable with a steep-pitch. The gable exhibits a boxed cornice and return eaves. The gable shows a Gothic sash window of 2/2 in its face. Two triangular pediment dormers with return eaves flank the cross gable. The dormers repeat the fenestration pattern of 6/6 double-hung windows with wooden sills.

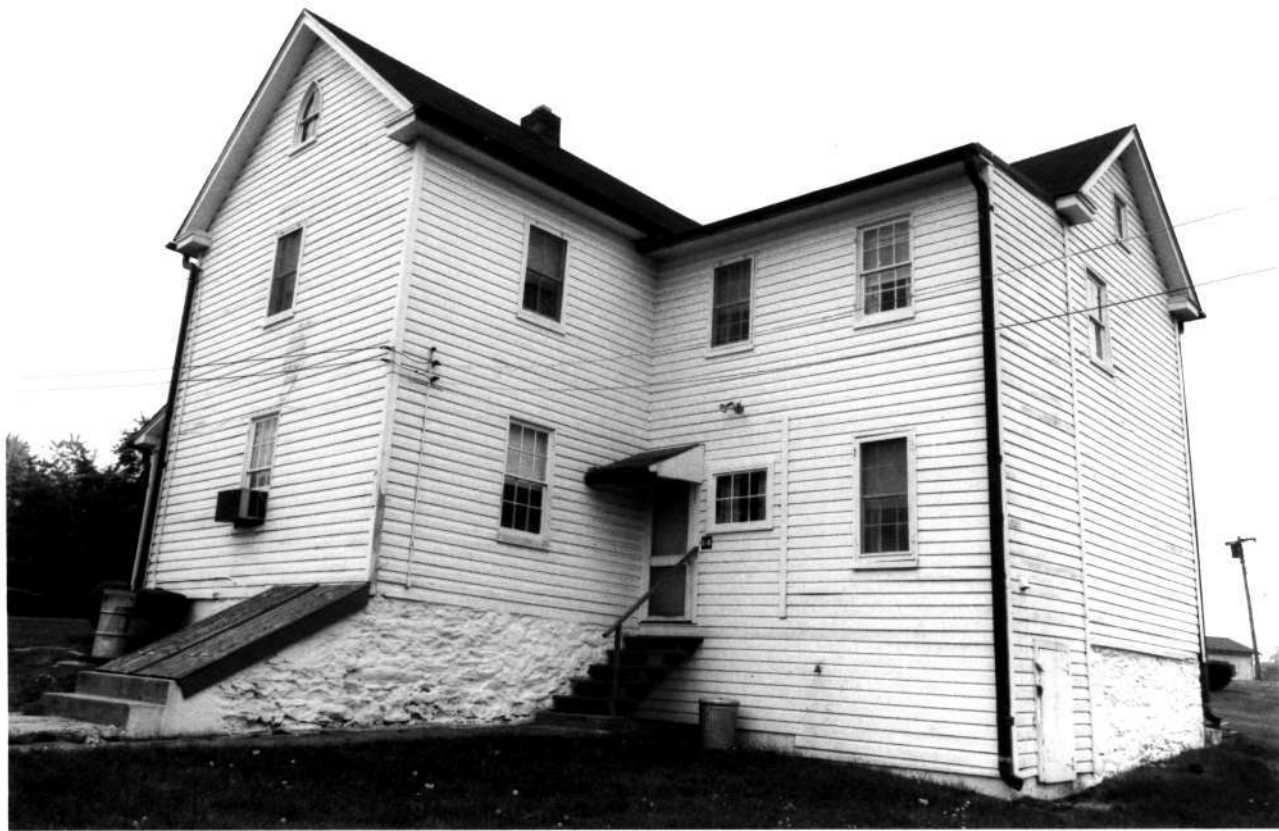
South

A two story shiplap addition is attached to the southern wall of the L extension. The addition displays a flat roof and measures a half bay deep. The fenestration repeats its pattern. A wooden door with an inverted cross pattern appears on this southern wall. A wooden lean-to roof shelters the entrance.

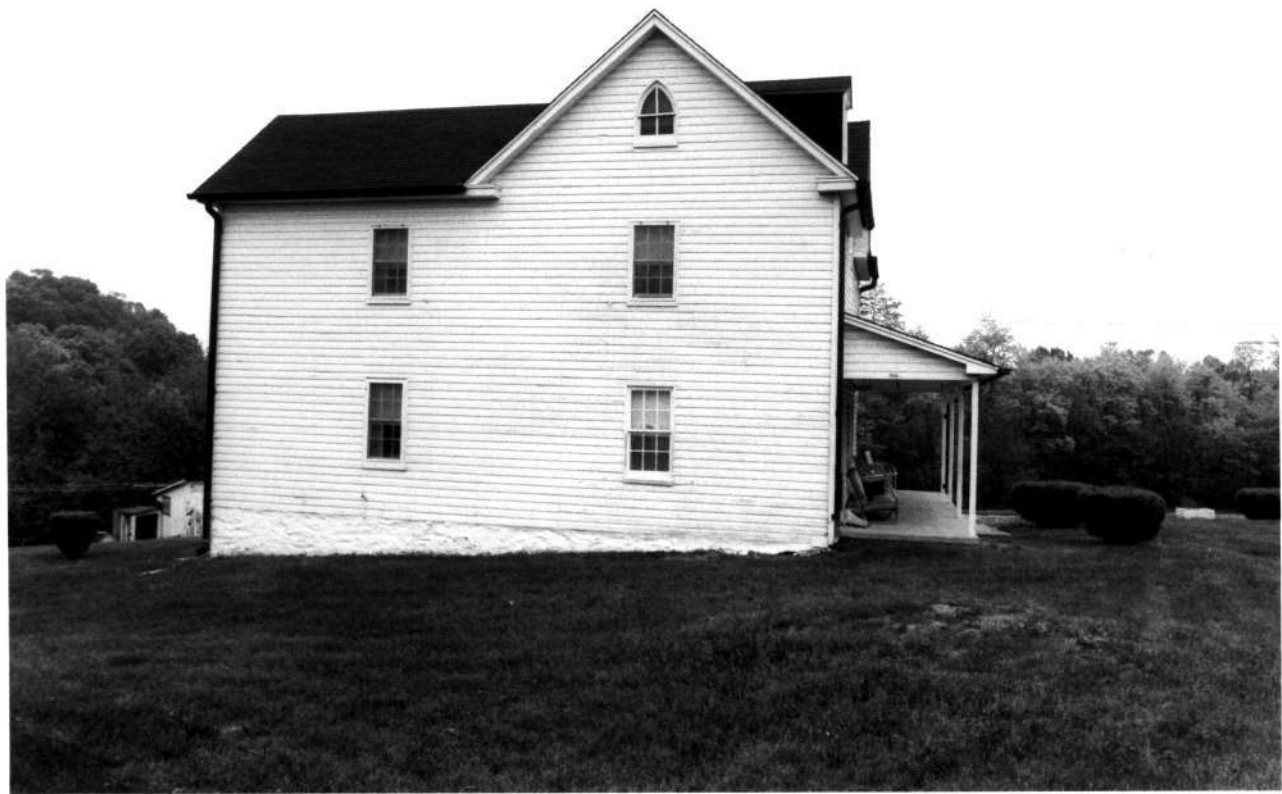
North

The gable ends appear on the north, south and east walls all have the same treatment. The gabled ends exhibits a boxed cornice with return eaves. A Gothic sash window is located under the peak of each gable.
